South Peninsula Hospital
 SPH Facility Assessment and Phased Renovation Plan
 Homer, Alaska

M4 Condensate Receiver Insulation

Observed Deficiency and Proposed Correction

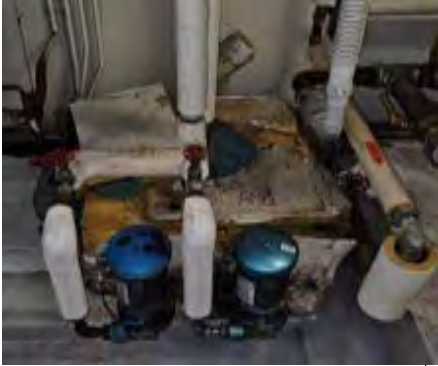
Condensate return unit A-8 located in Mech 120 is missing a significant amount of insulation from its body. While this insulation may have been modified to reduce the temperature of the condensate and prevent cavitation in the pumps, it should be done in a clearly intentional manner. This appears to have not been done intentionally and be a consequence of the age of the unit. This is a source of energy loss for the steam system.

the condensate return temperature should be examined at full load of the steam equipment it serves. The measured temperature should be compared with the manufacturer-recommended temperature. If the temperature is sufficiently low then the unit should be reinsulated. If the condensate is returning at the appropriate temperature then the unit should be reinsulated leaving approximately the same amount of area uninsulated and it should be done in a clean manner and intentional manner.

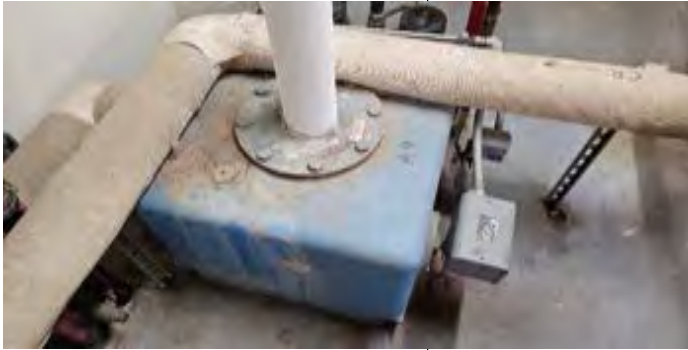
M5 Condensate Receiver Insulation

The condensate return unit is not insulated within the mechanical room. This causes increased heat transmission to the environment, and is a source of energy loss in the system. However it should be noted that sometimes when the condensate return temperature is too high cavitation issues can occur in the pump. This unit may be uninsulated if condensate return temperature is too high.

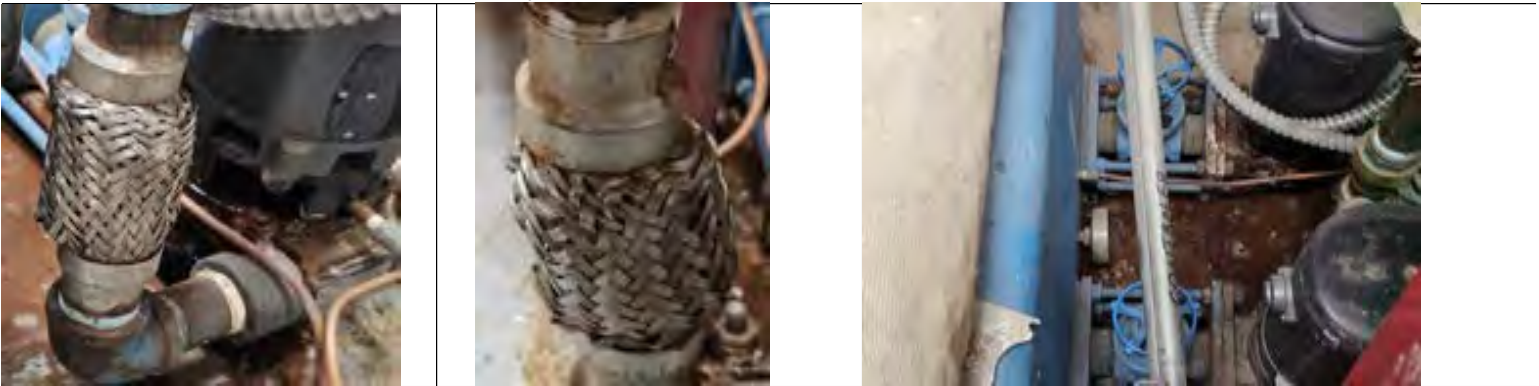
M6 CRU-1 (A-9) Leak and Damage

Narrative Description of Deficiency / Problem:
 The condensate return unit installed in 2006 CRU-1 has 2 issues visible here. The vibration isolators on both of the pumps appear to be crushed. One of the duplex pumps also appears to be leaking. This is likely due to a lack of support for the weight of the pipe.

Narrative Description of Correction / Resolution:
 The leaking pump needs to be repaired or replaced. The vibration isolators need to be replaced and properly supported to prevent them from expiriencing excessive weight. While down the condensate receiver should be checked for signs of corrosion and further actions may need to be taken from possible damage from the pool of condensate that has formed.

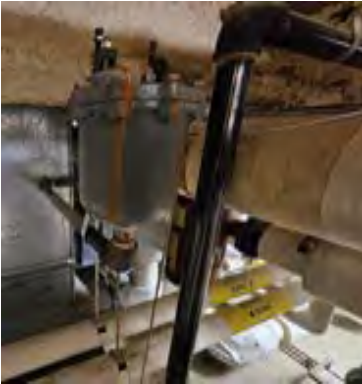
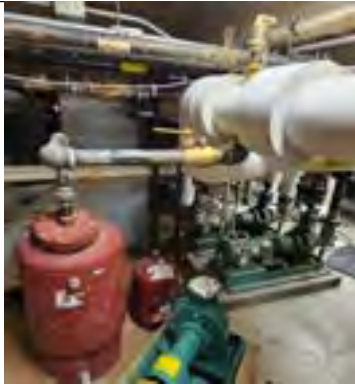
The hydronic heating system installed in 1999 feeds off the heat exchangers installed and used in the 1983 addition. The two systems pumps are installed in parallel and share the same fluid. The issue is the 1983 addition uses a air over water compression tank, and the 1999 addition uses an expansion tank. On the 1999 addition there is a automatic air vent. This will remove air from the system, air will diffuse back in to the system through the compression tank and cause it to repeatedly waterlog.

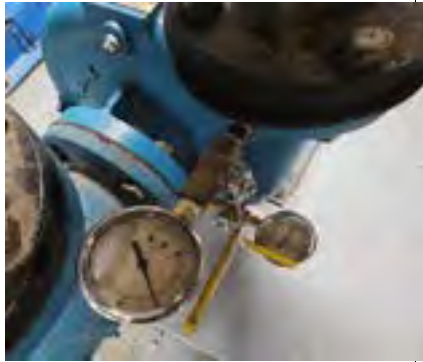
Narrative Description of Deficiency / Problem:
 Pump 2B 2006 which pumps the HWS was producing a gravel-like sound that is often caused by cavitation in the pump. This reduces the pump efficiency but will also greatly reduce the life of the pump.

Narrative Description of Correction / Resolution:
 The Pump should be investigated to confirm cavitation is occurring, then an investigation and resolution should be found to prevent future cavitation. Pump 2A was not running during the visit but it should also be investigated for the same issue. The impellers should also be examined if the damage from the cavitation is sufficient then the impellers may need to be replaced.

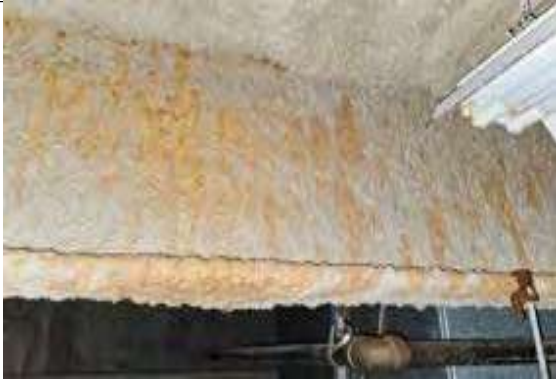
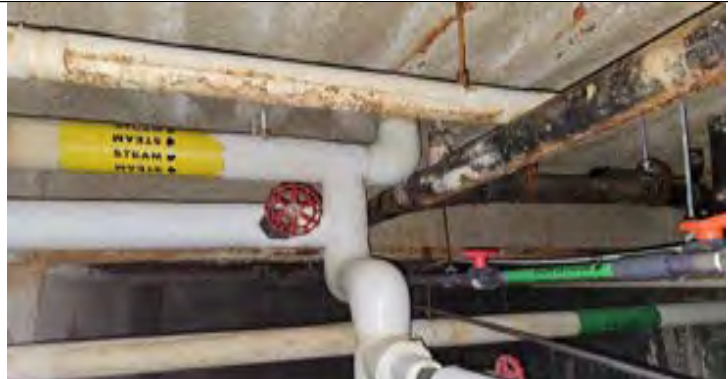
M9 Crawl Space Corrosion

Narrative Description of Deficiency / Problem:
 There were large amounts on corrosion on all surfaces in the space. Likely due to the washdown chemicals used in the spaces above.

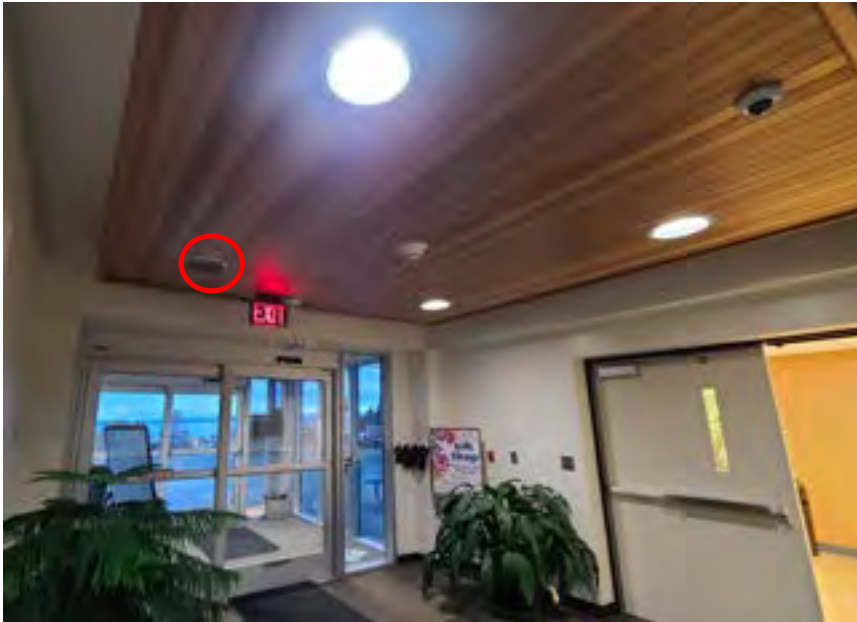
L1 Fixtures with bad ballasts
 Electrical
 Observed Deficiency and Proposed Correction

Entry - Recessed downlight reported to have bad ballast per Maintenance personnel. Fixture was observed 'off' for duration of site visit.
 Dining - Recessed downlight observed flickering while on site.

Record drawings indicate that the fixture with bad ballast in the entry way is the only fixture in that space fed from the Life Safety branch. As is, upon loss of normal power, there would be no illumination within the Entryway. See related deficiency L8.

Replace entire fixture with LED type luminaire.

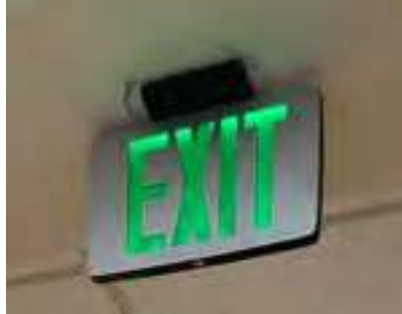
L4 Inconsistent Egress Signage
 Electrical
 Observed Deficiency and Proposed Correction

Multiple types of exit signs were observed throughout the Facility with the following variations:
 Types: Non-illuminated (powered) and illuminated (powered)
 Housing Colors: White, Black, Aluminum
 Housing Materials: Plastic, Aluminum
 Lettering Colors: Red and Green
 Accessories: With and without emergency lighting units (bug-eyes)

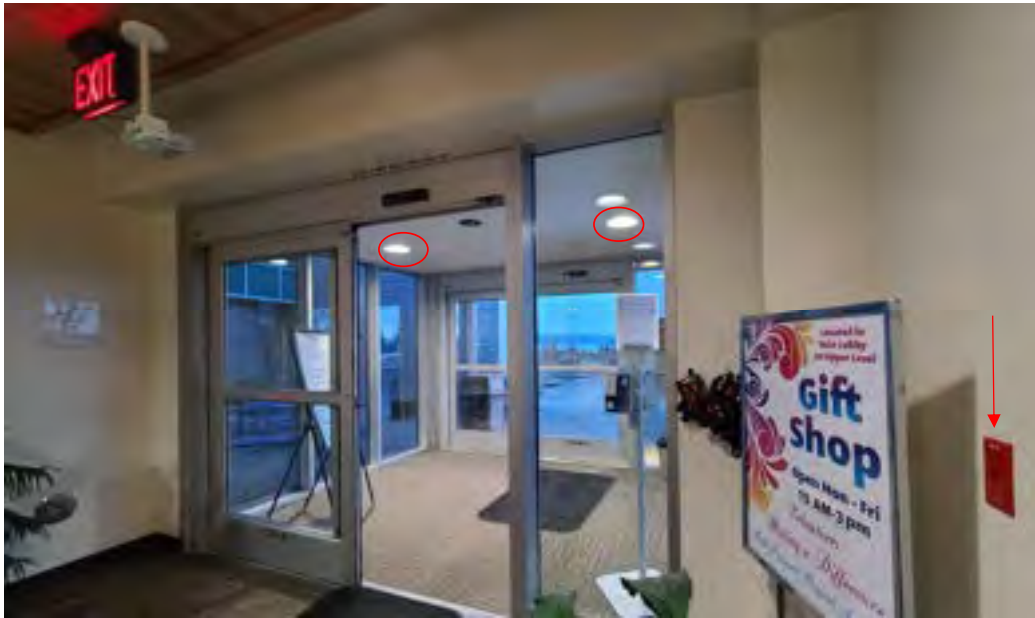
There are 3 fixtures within the entryway and vestibule that are controlled via manual on/off wall switch, and powered from the Life Safety branch. It appears that these fixtures are intended to provide illumination along egress path through the entry and vestibule. If these fixtures are not switched 'on' manually, upon loss of normal power, there is no illumination throughout the vestibule, and entryway which is designated as a path of egress.
 NFPA 101 7.8.1.2: Illumination of means of egress shall be continuous during the time that the conditions of occupancy require that the means of egress be available for use, unless otherwise provided in 7.8.1.2.2.

Record drawings indicate that the fixture with bad ballast in the entry way (not shown in picture above) is the only fixture in that space fed from the Life Safety branch. As is, upon loss of normal power, there would be no illumination within the Entryway. See related deficiency L1.

Remove manual controller and provide un-switched power from Life Safety branch equipment.
 Alternatively, replace manual controller with an automatic control device complying with NFPA 101 7.8.1.2.2.
