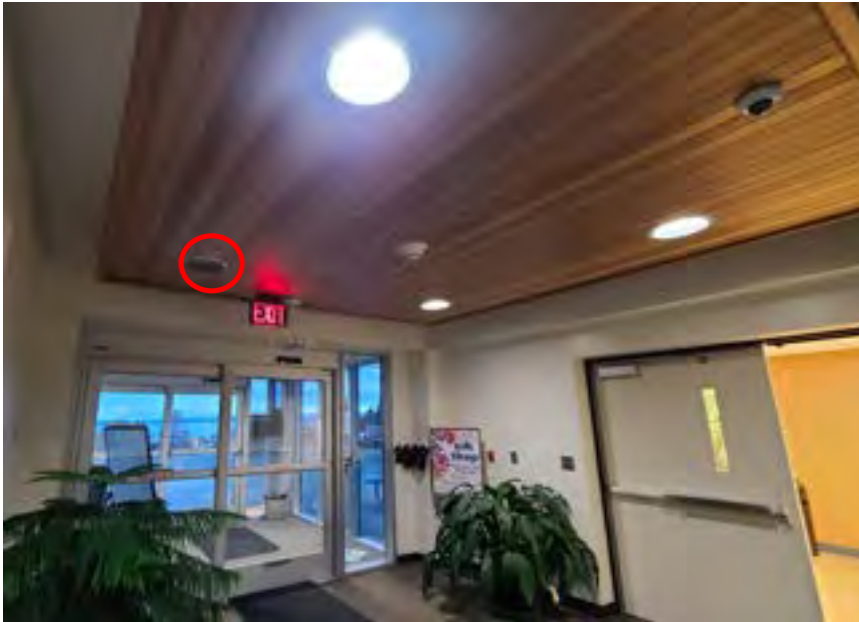
**L1 Fixtures with bad ballasts**  
**Electrical**  
**Observed Deficiency and Proposed Correction**

Entry - Recessed downlight reported to have bad ballast per Maintenance personnel. Fixture was observed 'off' for duration of site visit.  
 Dining - Recessed downlight observed flickering while on site.

Record drawings indicate that the fixture with bad ballast in the entry way is the only fixture in that space fed from the Life Safety branch. As is, upon loss of normal power, there would be no illumination within the Entryway. See related deficiency L8.

Replace entire fixture with LED type luminaire.

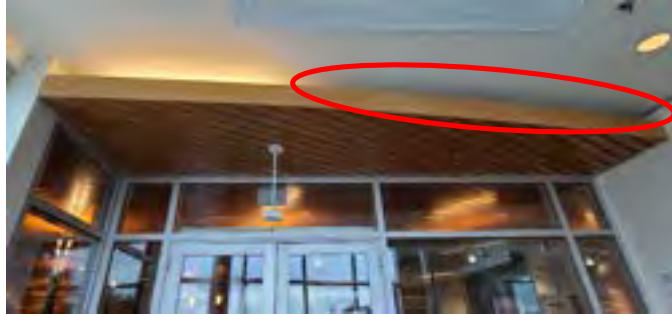
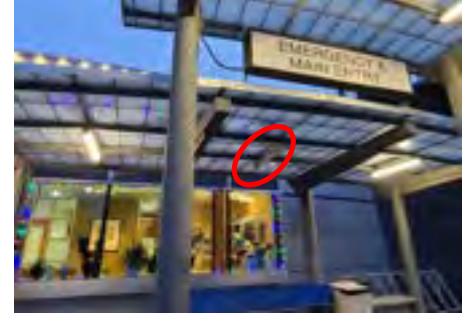
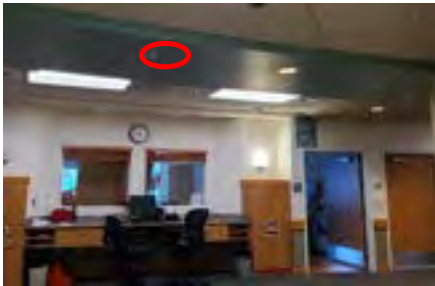
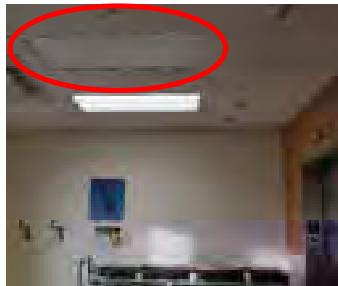
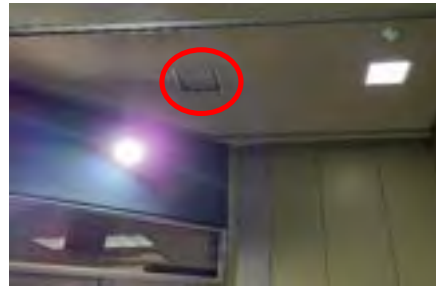
**L3 Failed Lamps**

Numerous fixtures observed with lamps that have failed or reached end of life. Fixtures were observed 'off' during site visit.  
 1st Floor - Recessed 2x4 in Corridor outside Electrical Room  
 2nd Floor - Recessed downlights at: Reception in ER lobby, Corridor outside Elevator A, Corridor outside Acute care patient room, and Corridor outside Imaging Suite. Linear fixtures in ER entryway.  
 3rd Floor - Recessed 2x4 in Elevator lobby  
 Exterior - Linear strip fixture at ER entry, recessed MH downlight at southwest LTC entrance, wall-mounted fixture above doorway on north side.

Interim: Provide new lamps in existing fixtures.  
 Long Term: Replace entire fixture with LED type luminaire.

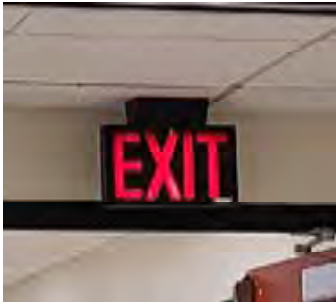
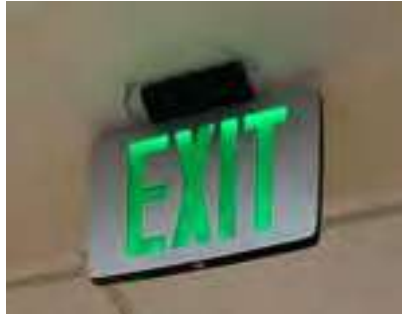
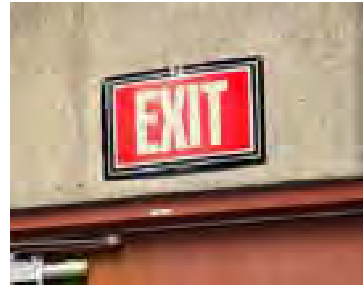
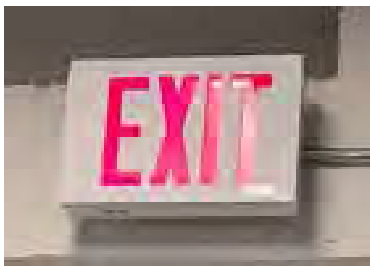
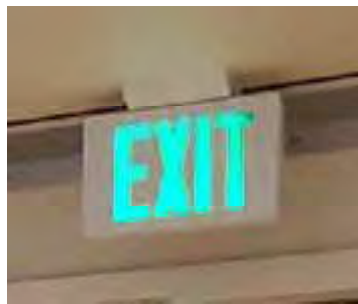
Multiple types of exit signs were observed throughout the Facility with the following variations:  
 Types: Non-illuminated (powered) and illuminated (powered)  
 Housing Colors: White, Black, Aluminum  
 Housing Materials: Plastic, Aluminum  
 Lettering Colors: Red and Green  
 Accessories: With and without emergency lighting units (bug-eyes)

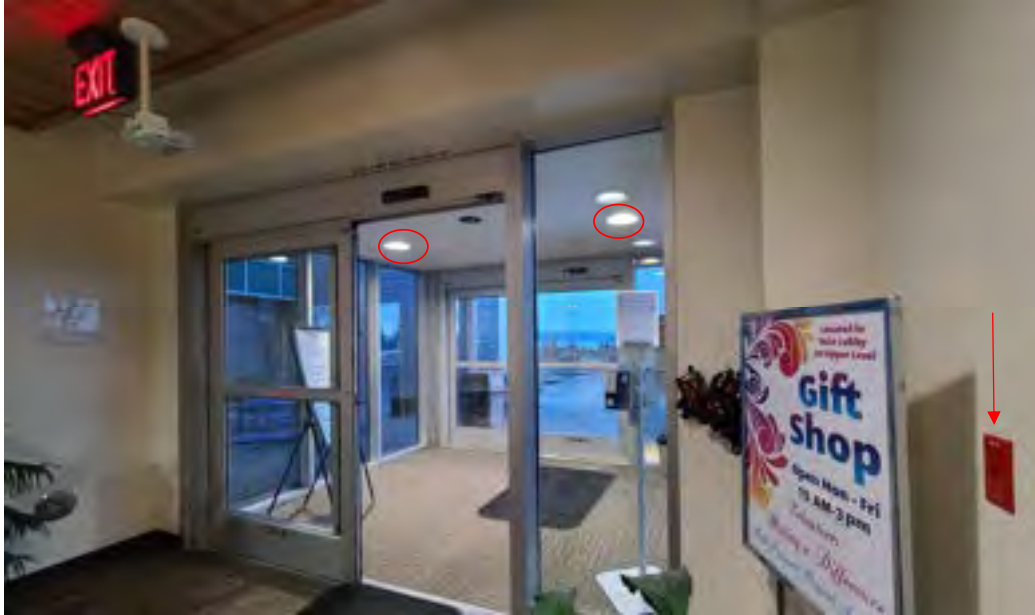
NFPA 101 7.8.1.2: Illumination of means of egress shall be continuous during the time that the conditions of occupancy require that the means of egress be available for use, unless otherwise provided in 7.8.1.2.2.

See related deficiency L1.

Alternatively, replace manual controller with an automatic control device complying with NFPA 101 7.8.1.2.2.

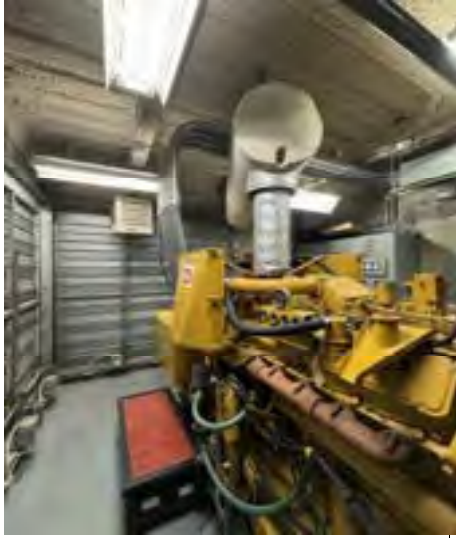
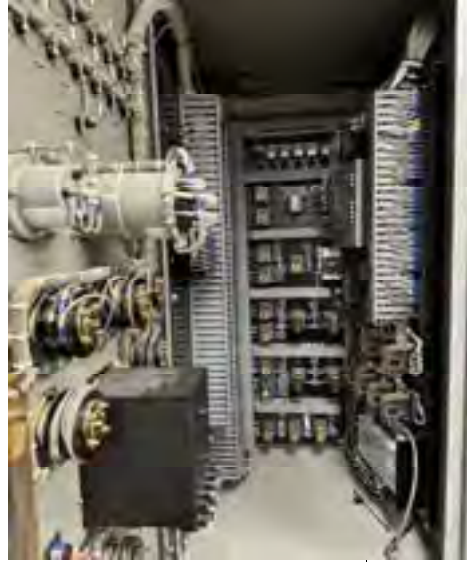
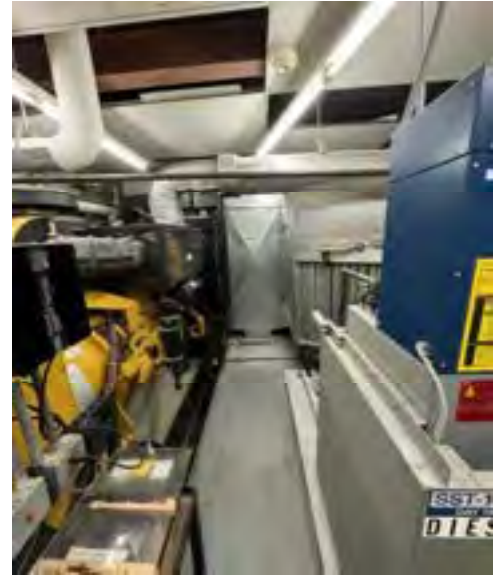
E2 Generator Age  
 Electrical  
 Observed Deficiency and Proposed Correction

Generator 1 (plan north) was replaced about 2005 and generator 2 (plan south) was replaced in 1983. Generator 2 is quite old and in fair to poor condition.

Replace generator 2. Consider relocating and replacing both generators.

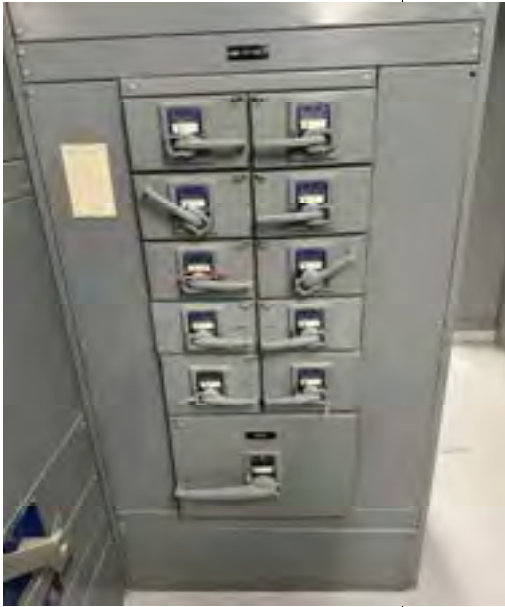
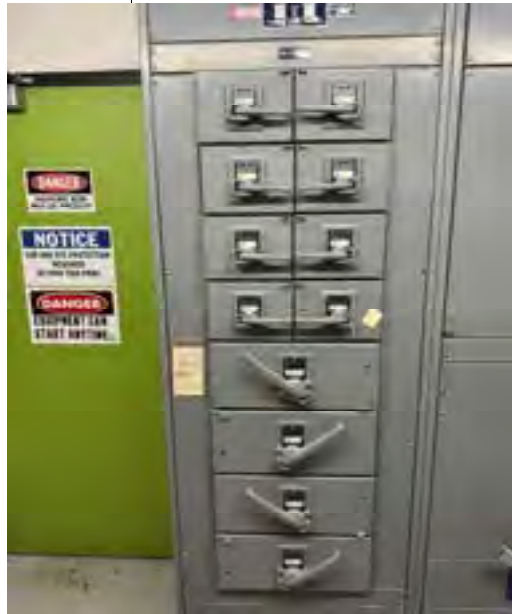
**E4 Age of Electrical Switchgear**  
 Electrical  
 Observed Deficiency and Proposed Correction

Main sections of switchgear in the main electrical rooms are quite old. Some of the switchgear is from 1974 (MDP and HMDP). Some of the switchgear (CDP4, EQDP6, Sub MDP, and CMDP) were installed in 1983. Some of the switchboards (EQDP8, CDP6, and NMDP) were installed in 1999. There are some lower ampacity distribuion panels that were installed in the late 70's and early 80's in the central mech room and plan north of the main conference room. Parts and components to maintain and repair these will becoming increasingly hard to find.

Replace main switchgear with smaller footprint equipment and include electronic trip breakers for coordination requirements.

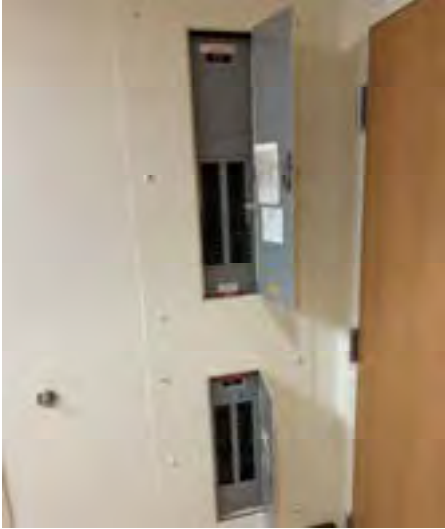
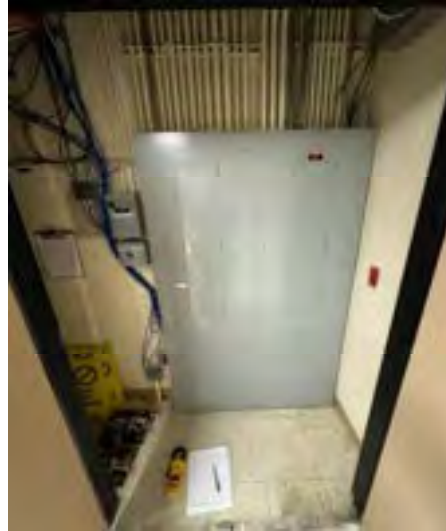
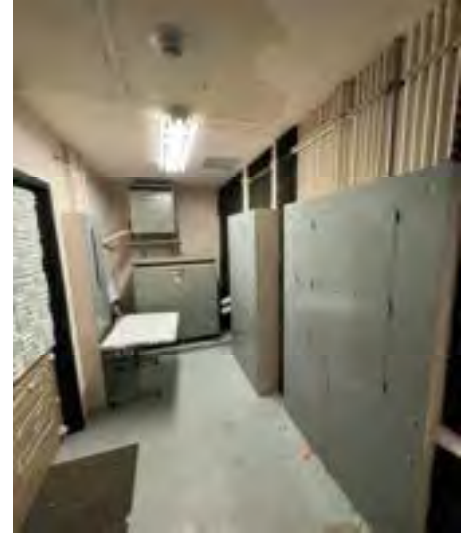
**E5 Age of Electrical panels**  
**Electrical**  
**Observed Deficiency and Proposed Correction**

Many panels are from the late 70's and early 80's. Many other panels are from 1999. There are a few panels that have been installed more recently as well. Parts and components to maintain and repair these will becoming increasingly hard to find.

Replace panels. Provide electronic trip breakers for coordination.
