South Peninsula Hospital
 SPH Facility Assessment and Phased Renovation Plan
 Homer, Alaska

M4 Condensate Receiver Insulation

Observed Deficiency and Proposed Correction

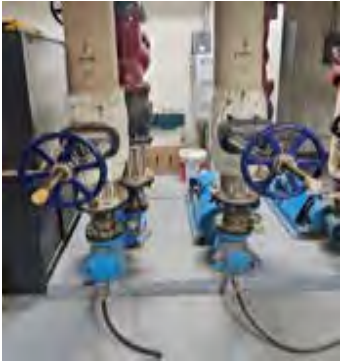
Room Number	Room Name	SQFT of Area (if Applicable)
112	Boiler Room

Narrative Description of Deficiency / Problem:
 Pump 2B 2006 which pumps the HWS was producing a gravel-like sound that is often caused by cavitation in the pump. This reduces the pump efficiency but will also greatly reduce the life of the pump.

Narrative Description of Correction / Resolution:
 The Pump should be investigated to confirm cavitation is occurring, then an investigation and resolution should be found to prevent future cavitation. Pump 2A was not running during the visit but it should also be investigated for the same issue. The impellers should also be examined if the damage from the cavitation is sufficient then the impellers may need to be replaced.

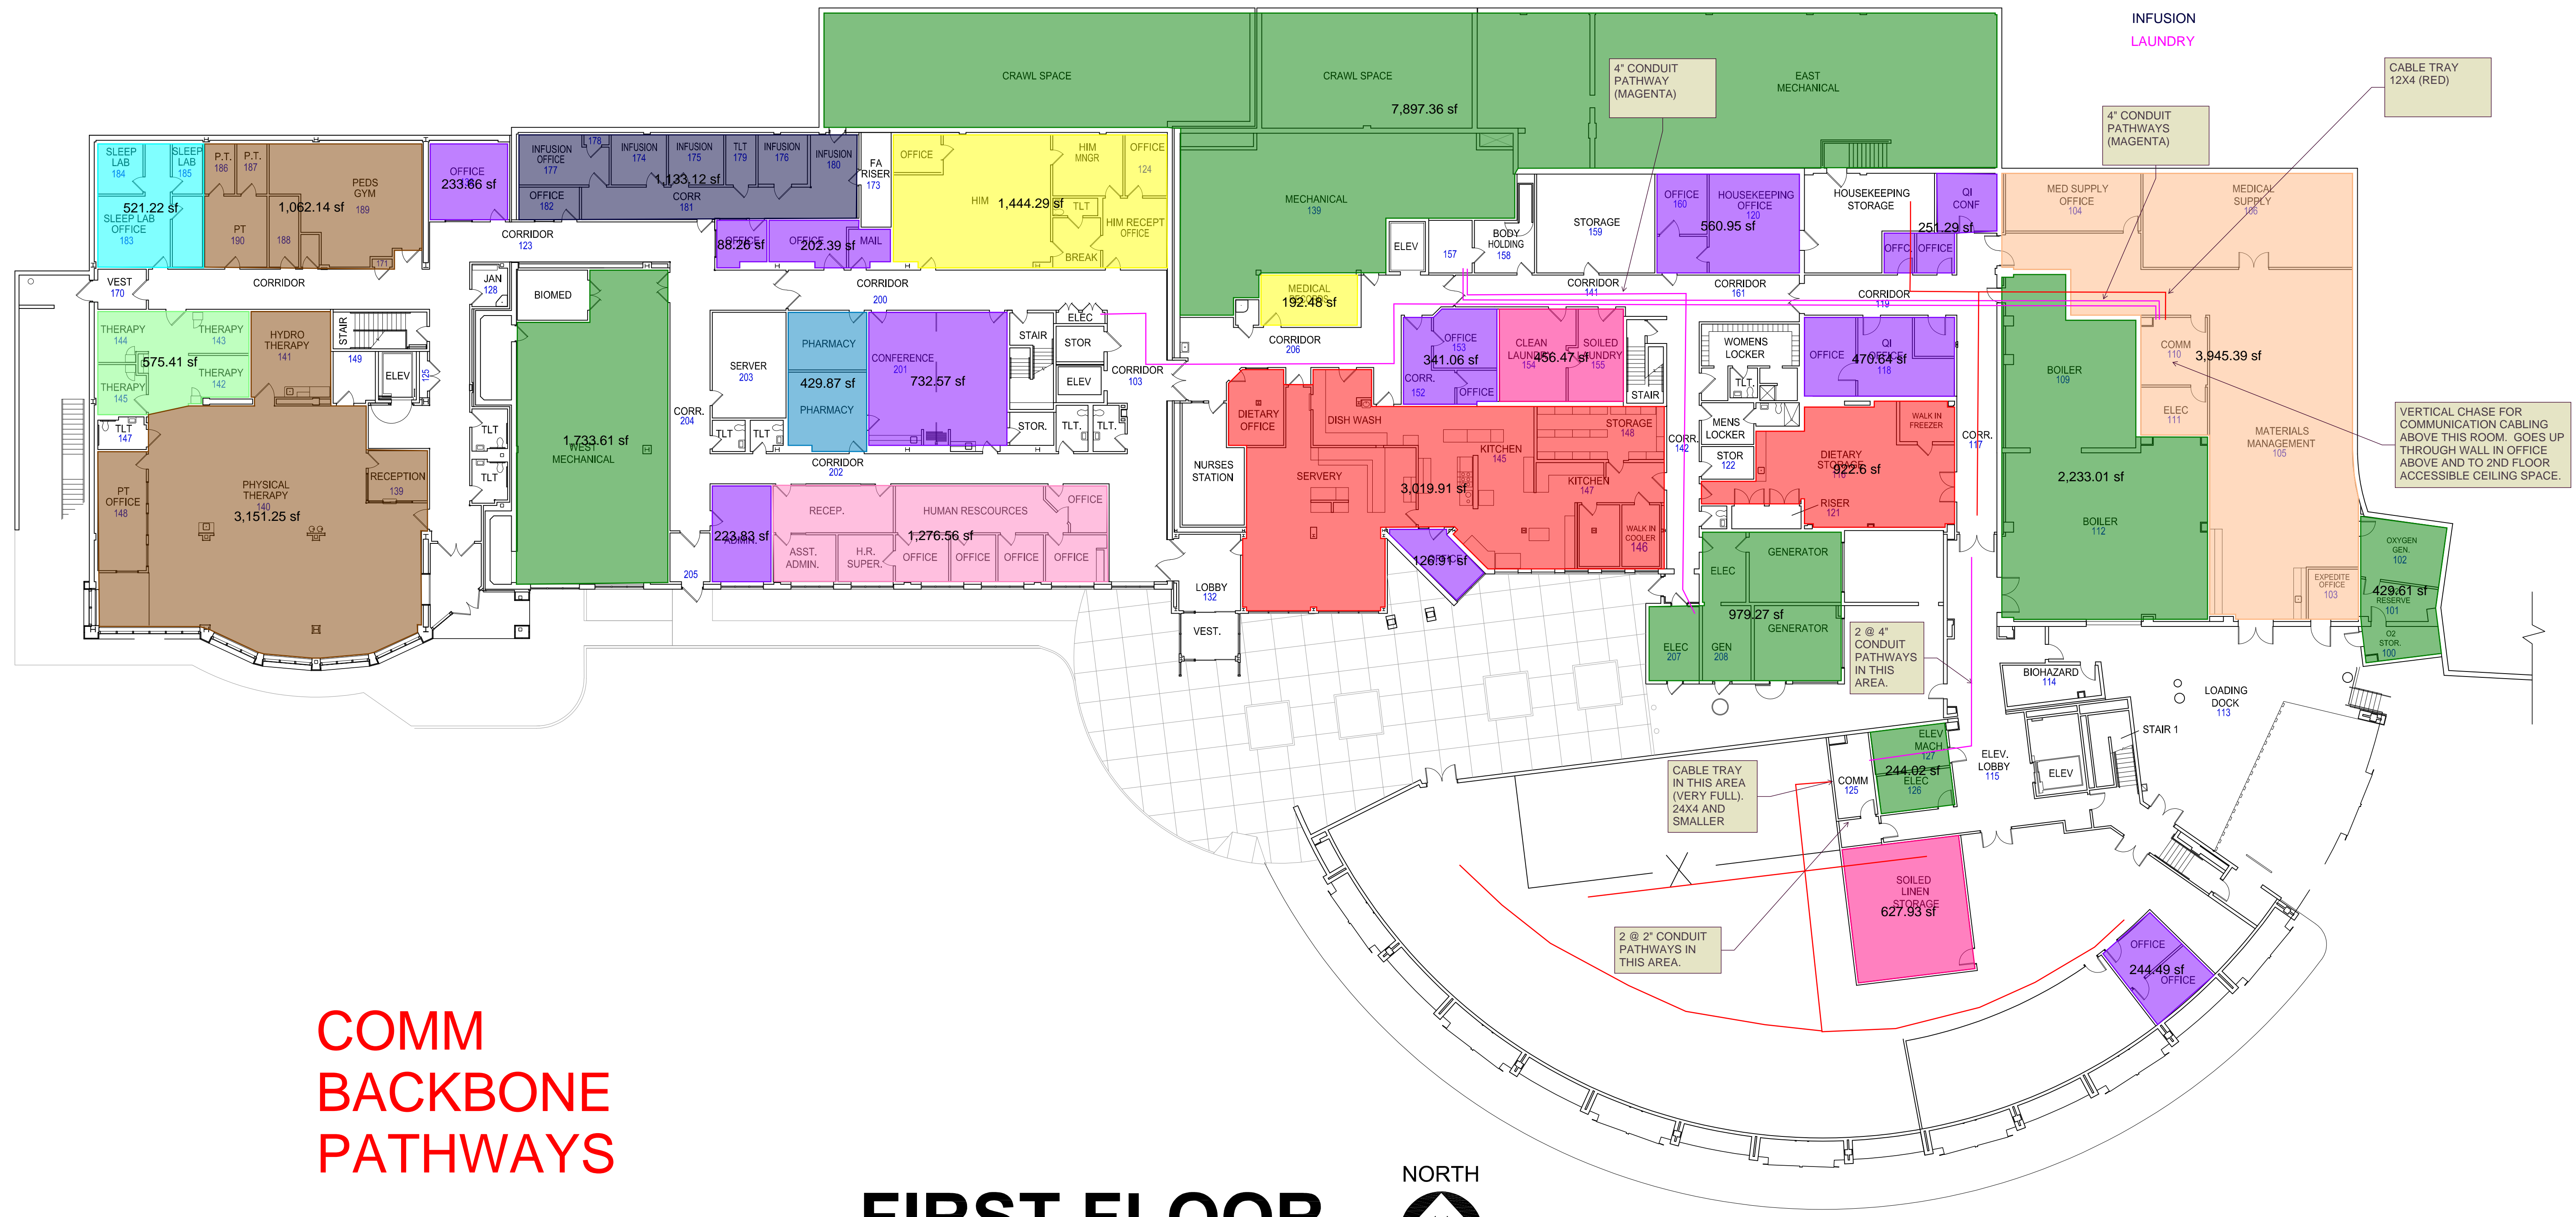
**COMM
 BACKBONE
 PATHWAYS**

MECHANICAL / ELECTRICAL
 FIBER OPTIC CABLING DOES RUN BETWEEN MAIN SERVER ROOMS AND MAIN COMM ROOMS BUT IS GENERALLY ABOVE CEILING IN J-HOOKS OR ON CEILING TILES. LIMITED COMM PATHWAYS ARE SHOWN OR NOTED.

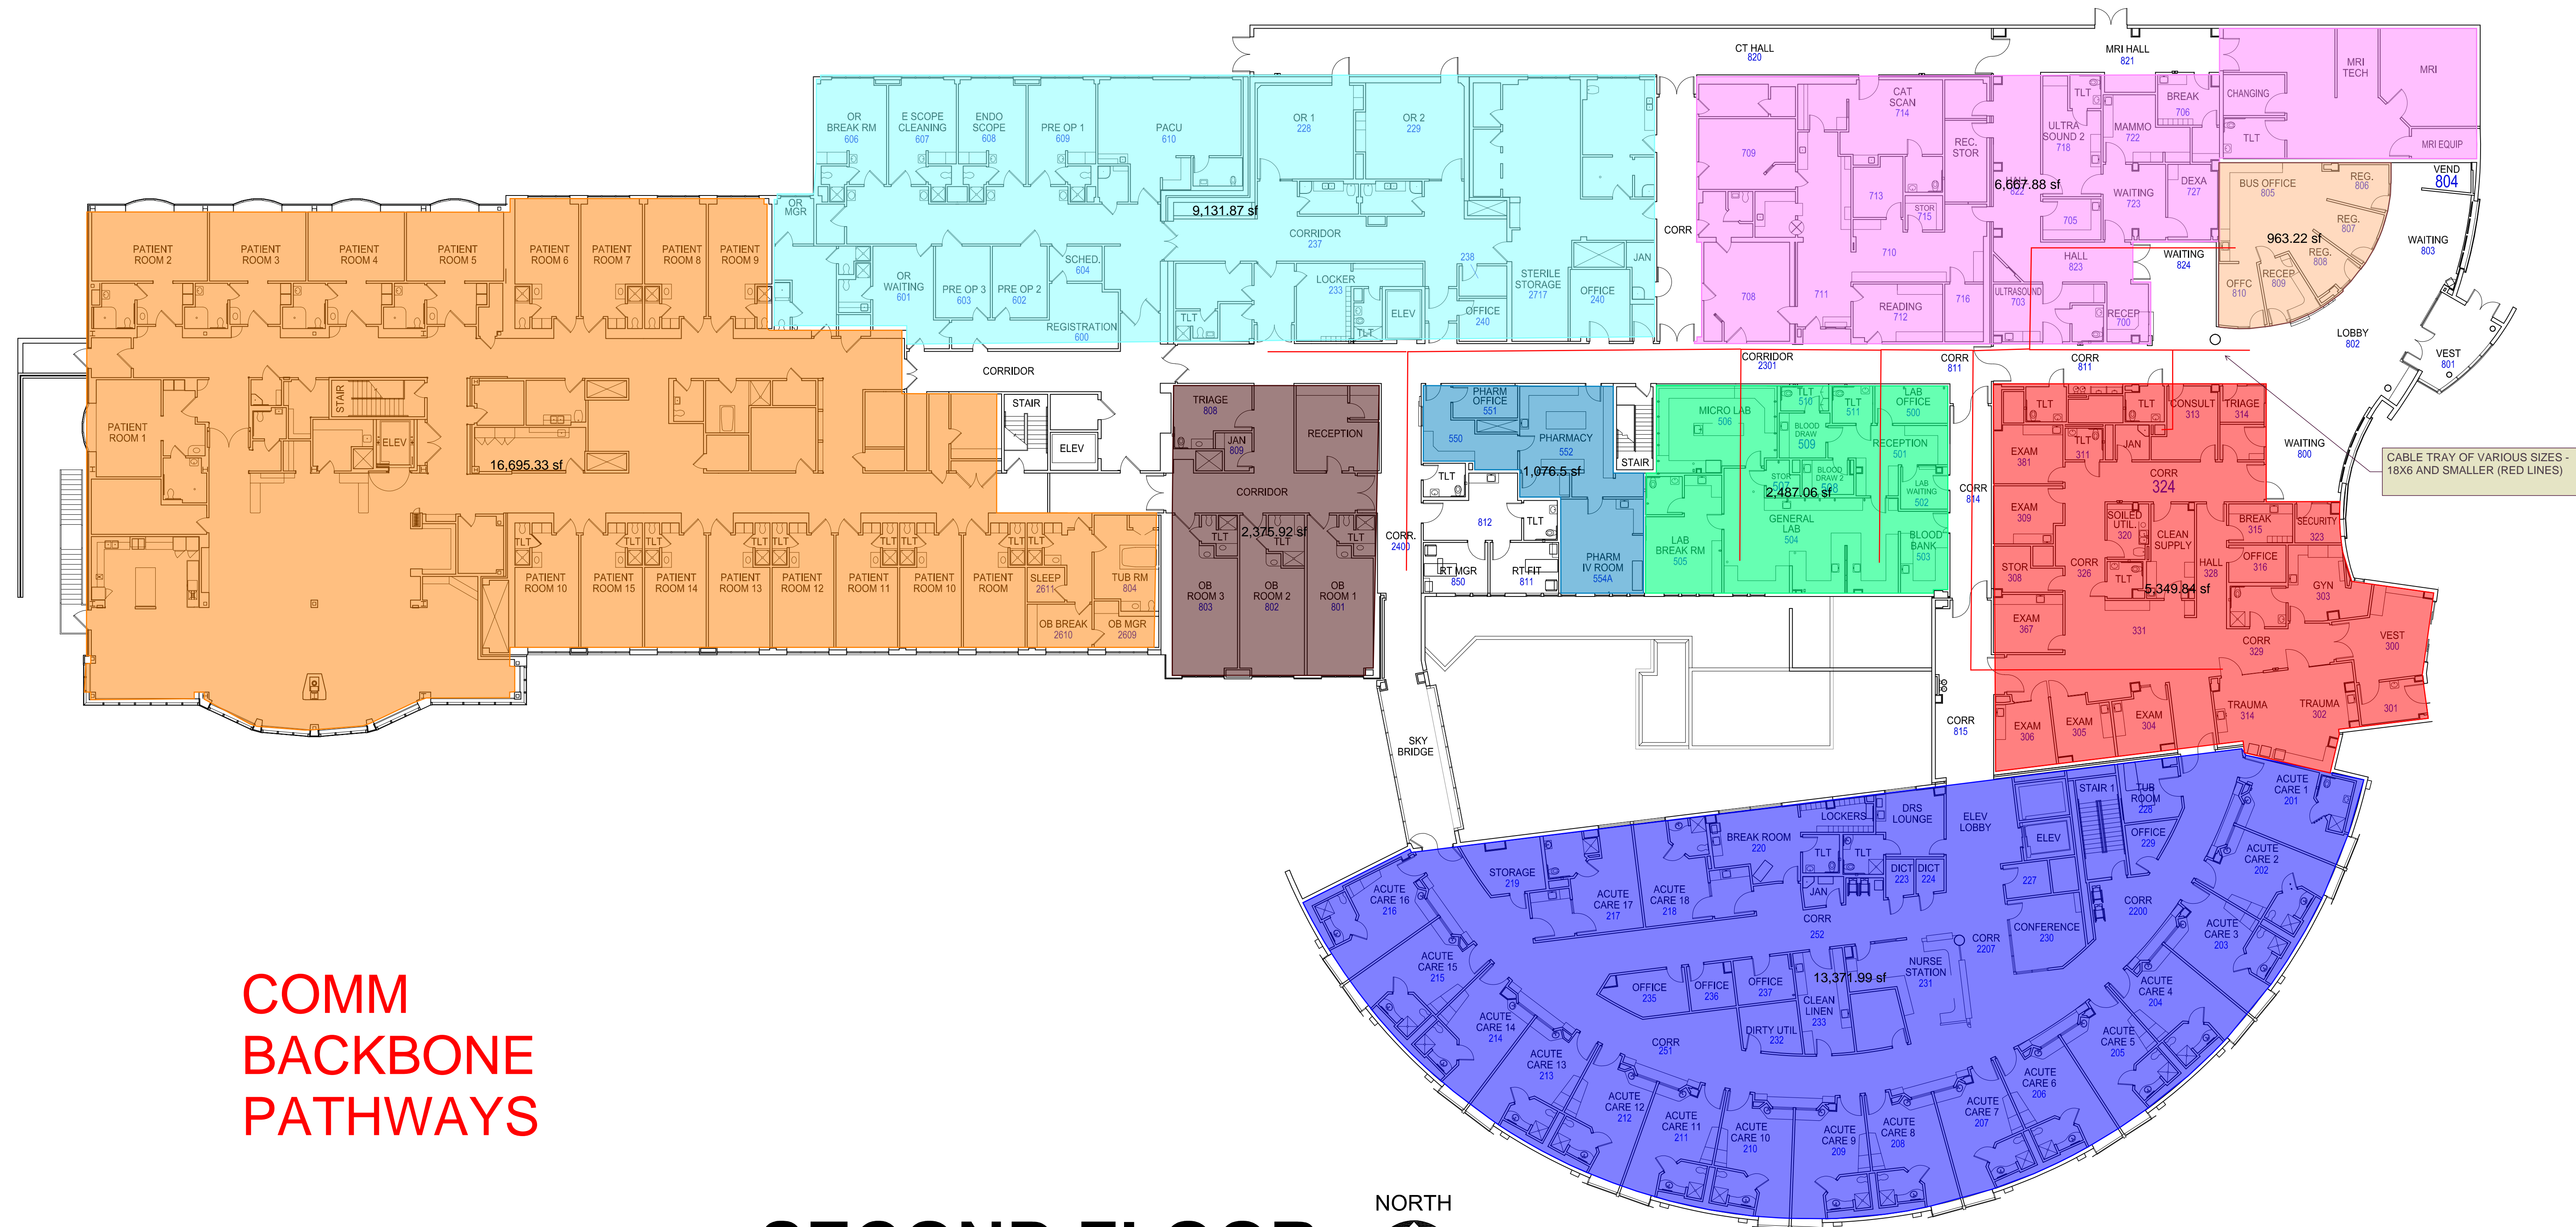
**COMM
BACKBONE
PATHWAYS**

COMMUNICATION CABLING DOES RUN BETWEEN SERVERS AND CLOSETS BUT IS GENERALLY ABOVE CEILING IN J-HOOKS OR ON CEILING TILES. LIMITED COMM PATHWAYS ARE SHOWN OR NOTED.

NO KNOWN BACKBONE PATHWAYS BETWEEN ANY OF THESE TELECOM AREAS AND ROOMS EXCEPT FOR COUPLE NOTED.

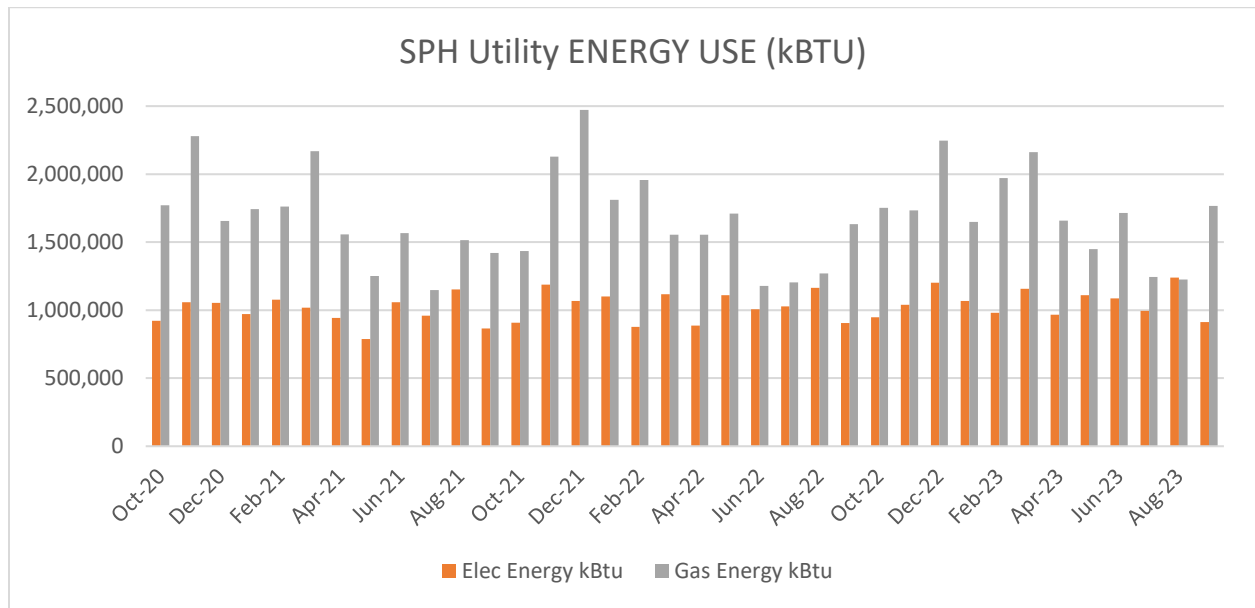
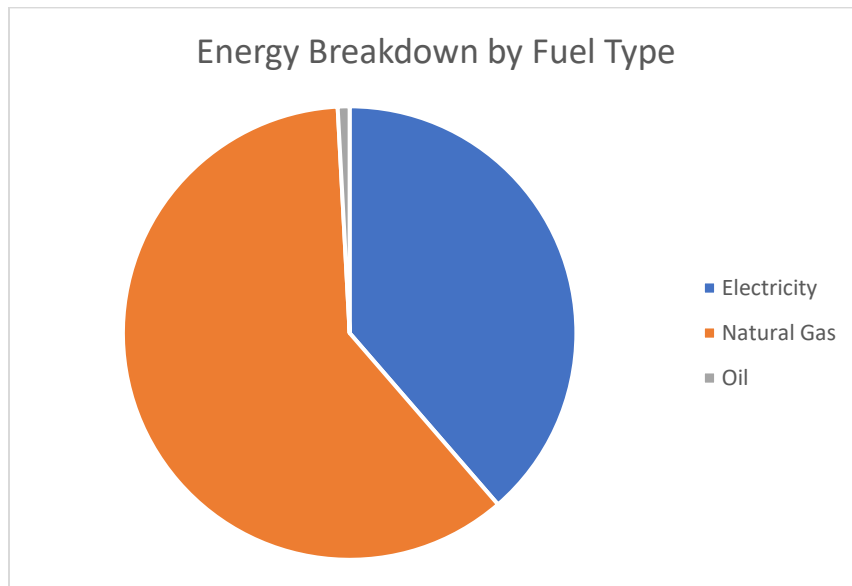
Electricity consumption is steady at approximately 1 million kbtu per month. Thermal energy consumption varies with weather conditions and is therefore higher in winter months and lower in summer but never drops below 1.2 million kbtu per month. Natural gas accounts for nearly 2/3 of the energy consumed at the hospital.

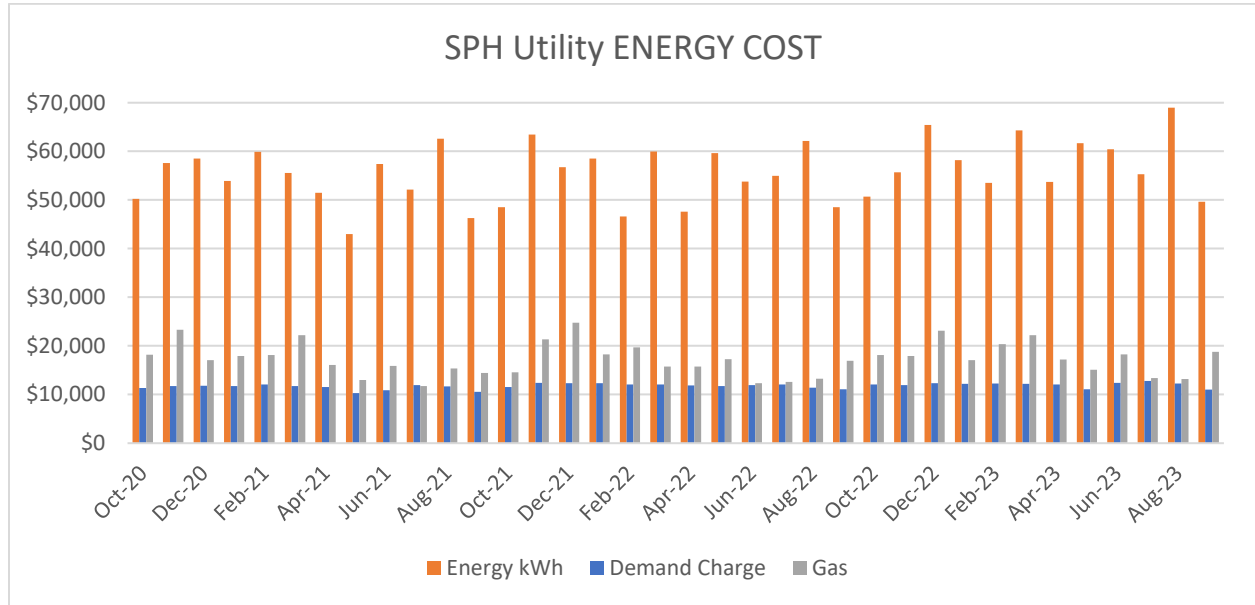
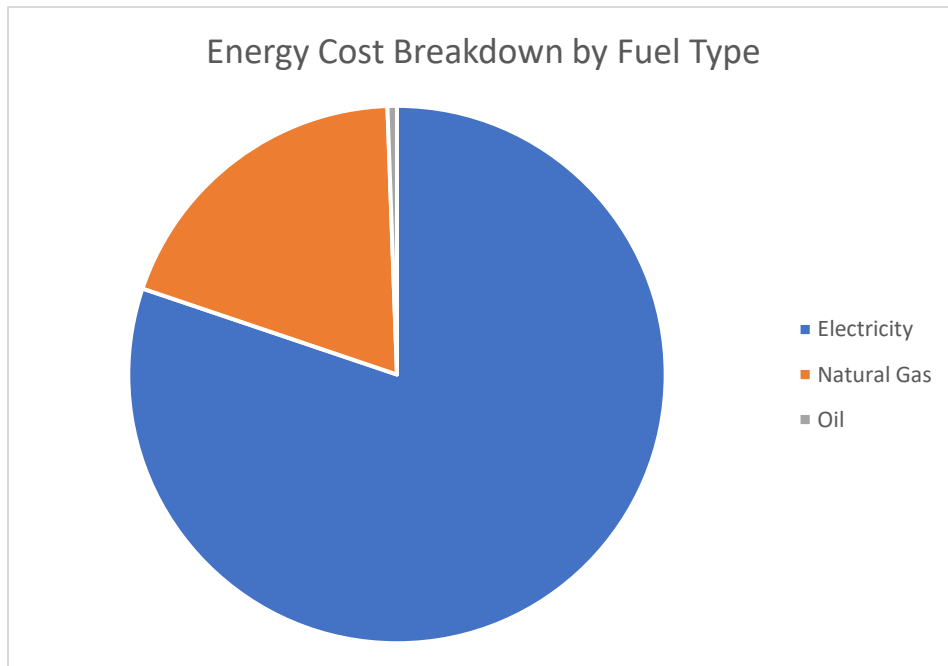
The corresponding costs for the same time period are shown in the two graphs below. It's evident that the demand charge for electricity is nearly constant, and that electrical energy charges dominate the expenses. Total energy costs per year run approximately \$1 million. Over 3/4 of the energy cost is associated with electricity.

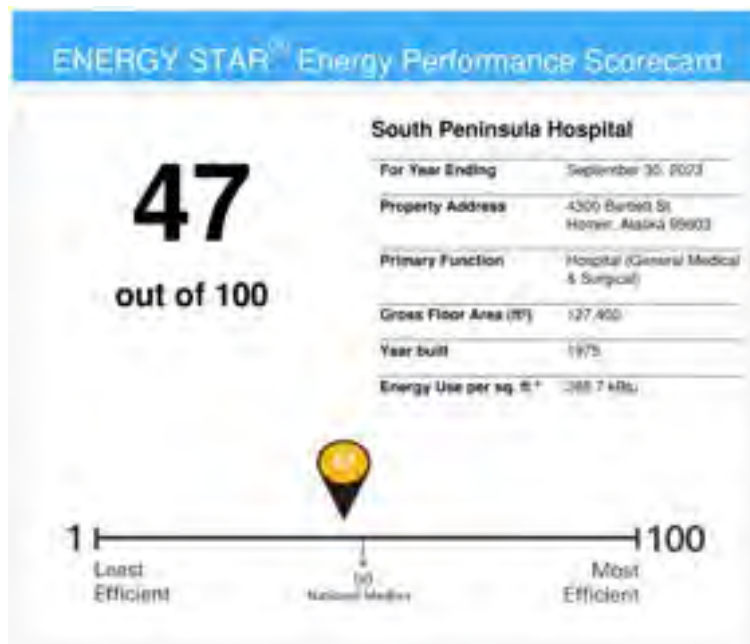
Entering the same utility data into the online Energy Star Portfolio Manager leads to a score of 47 out of 100. This means that approximately half of similar facilities use more and half use less energy than South Peninsula Hospital. Put another way, South Peninsula Hospital is about average in energy consumption among similar hospitals.

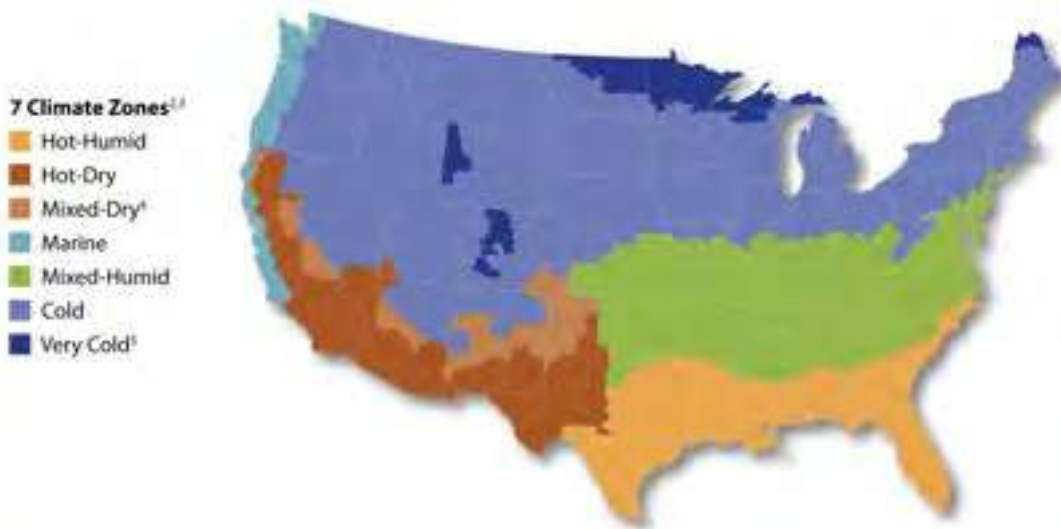
Based on those criteria, the average EUI would be expected to be 255, which compares favorably to the calculations of approximately 255-265, and supports the statement that SPH is about average energy consumption.
