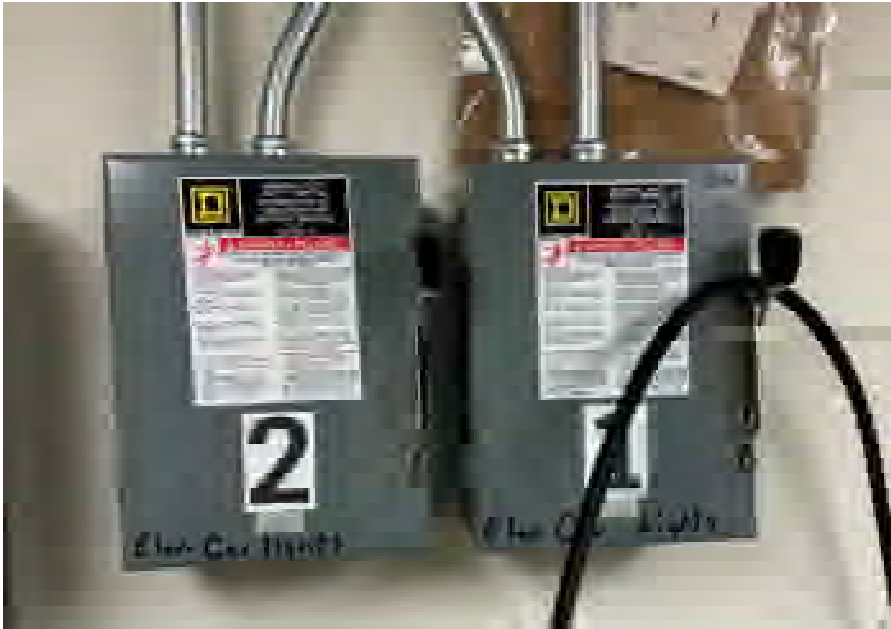
**Department or Area**  
 Elevators
